**THE EFFECTS OF ENVIRONMENT ON THE INTERLAMINAR SHEAR
PERFORMANCE OF AN OXIDE/OXIDE CERAMIC MATRIX COMPOSITE AT
ELEVATED TEMPERATURE**

THESIS

AFIT/GAE/ENY/07-J11

AIR FORCE INSTITUTE OF TECHNOLOGY

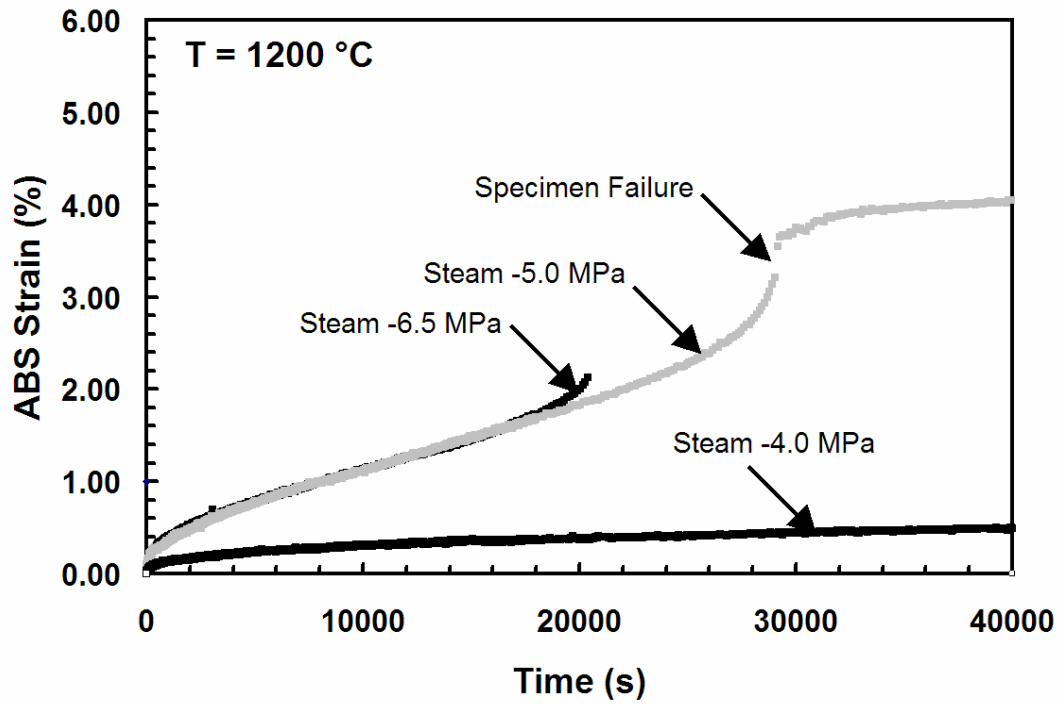
Figure 33: ABS Strain vs. Time curve for interlaminar shear creep tests on N720/A in steam at 1200°C with a truncated time scale.

^a Time taken from the point of failure on Figure 33.

The specimens tested in creep at –5.0 and –6.5 MPa exhibited primary, secondary, and tertiary creep as seen in Figure 33, where the time scale is truncated to clearly show creep curves obtained at these stress levels. The creep curve in Figure 33 clearly shows that the specimen failed after ~8 h of creep testing. However, the failure detector did not “catch” failure and trigger system shutdown, likely because the load level never fell below 85% of the maximum load magnitude. Thus the test continued until 100 h elapsed as shown in Figure 34. After the conclusion of the 100 h test, the specimen was removed from the MTS machine. Apparently the two notches had closed during the test and, what is particularly noteworthy, the matrix at the opposite sides of each notch sintered together during the remaining 92 h of testing following specimen failure. The specimen did not separate into two parts after it was removed from the testing machine. The optical

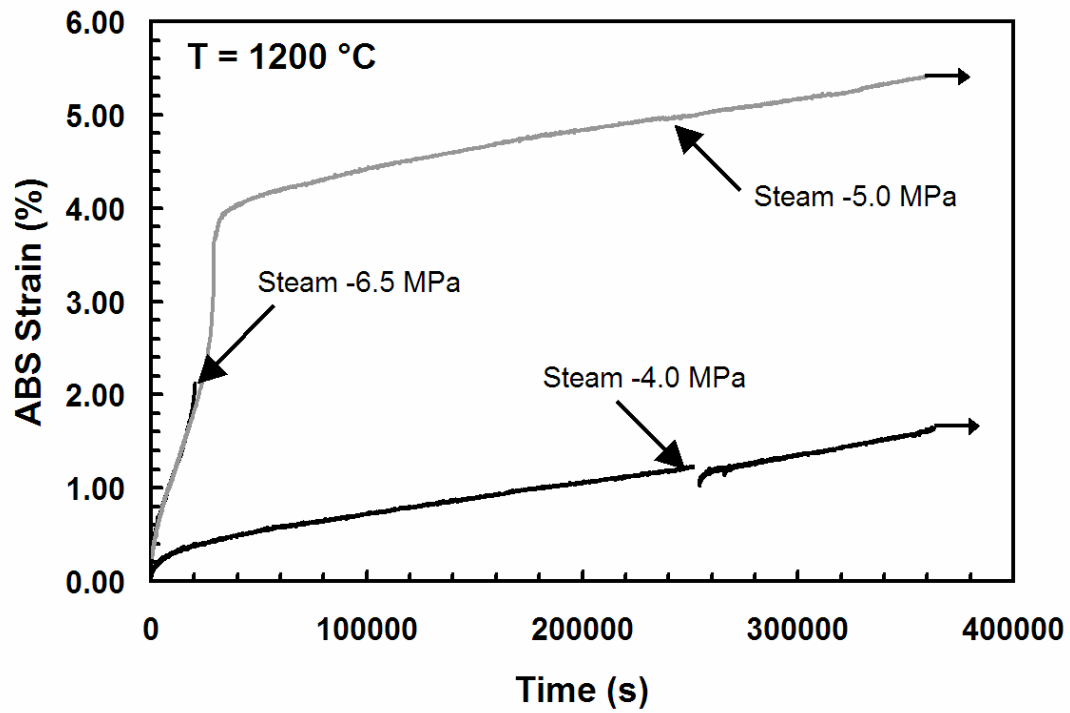
Figure 34: ABS Strain vs. Time curve for interlaminar shear creep tests on N720/A in steam at 1200°C.

Compressive creep tests were carried out at 1200°C in steam at the stress levels of –4.0, –5.0, and –6.5 MPa. In tests conducted at lower absolute values of stress, it was important to carefully adjust the failure detector tolerance. On one hand, the tolerance had to be small enough to trigger system shutdown immediately after failure occurred to prevent continuing compression and secondary failure. On the other hand, the tolerance had to be large enough not to trigger system shutdown due to normal fluctuation in the force level (electrical noise inherent in the load cell signal). After numerous trials, the correct tolerance level was found and employed in tests. Creep strain vs. time curves obtained at 1200°C in steam are presented in Figure 34. Run-out of 100 h was achieved in the –4.0 MPa test only.

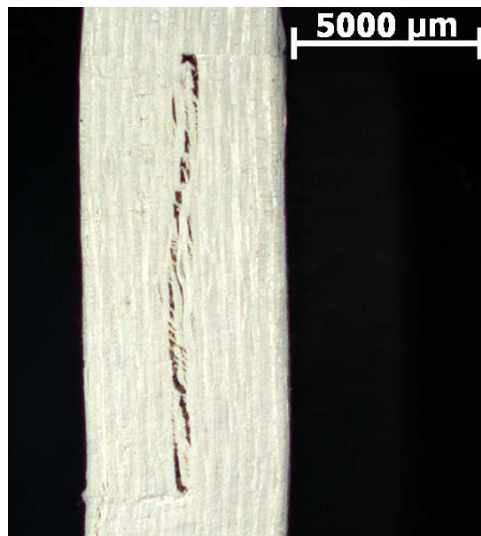
Figure 35: N720/A specimen re-sintered after 92 h of creep at -5.0 MPa at 1200°C in steam.

micrograph seen in Figure 35 shows the notches closed and “re-sintered” as well as the side view of the fracture surface. Also, the fracture surface does not appear planar.

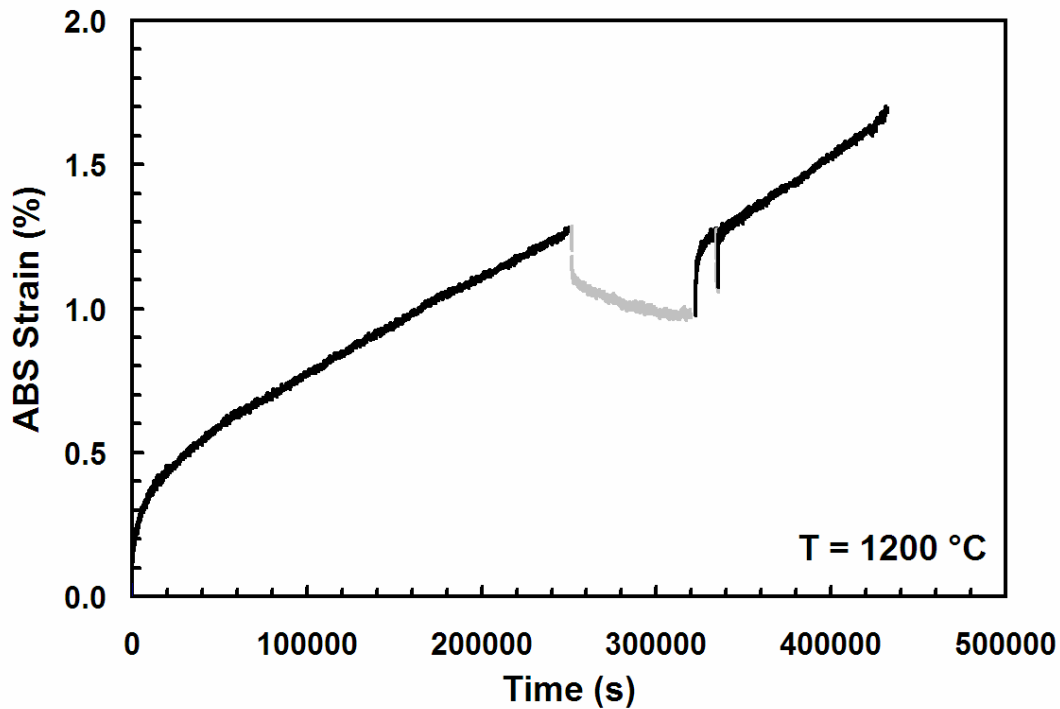
Figure 36: Complete history of specimen 12 (4 MPa Creep).

It is seen that the creep curve obtained at the stress of -4.0 MPa exhibits only primary and secondary creep regimes (See Figure 36). The creep curve also shows that the test was interrupted after approximately 70 h of creep. Fluctuations of the load cell signal triggered the failure detector, which caused the specimen to be unloaded to zero stress. Following the unloading, the specimen continued to dwell at zero stress for approximately 19 h. During this entire time, the specimen remained at 1200°C in steam environment. After ~19 h dwelling at zero stress, the creep test was restarted. It is noteworthy that during the dwell at zero stress, the specimen recovered some of the creep strain as shown in Figure 36. It is also noteworthy that after restart, the specimen exhibited a secondary creep regime with approximately the same minimum strain rate that was observed prior to the interruption.

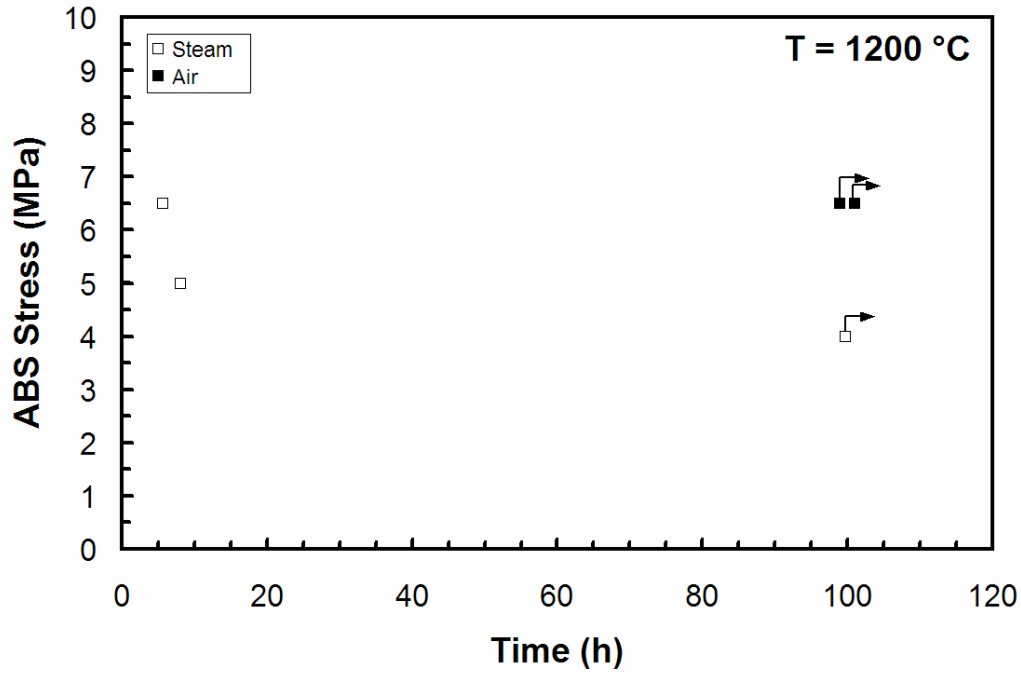
Figure 37: Rupture stresses for all N720/A creep specimens versus the survival time at 1200°C.

It is seen that the presence of steam has a degrading effect on the interlaminar shear performance under sustained loading (See Figure 37). The results of the monotonic compression test conducted on a N720/A DNS aged for 24 h at 1200°C in steam revealed that there was no decrease in strength, but some increased propensity for inelastic straining due to prior aging. Conversely, the results of the creep tests conducted in air and in steam reveal drastic deterioration of the creep performance under sustained interlaminar shear stress in steam. The behavior of the composite under this type of loading is matrix-dominated. Therefore, results indicate that matrix strength and creep resistance is significantly affected by exposure to steam environment under load. On the other hand, effects of no-load exposure to steam at 1200°C are not nearly as dramatic.

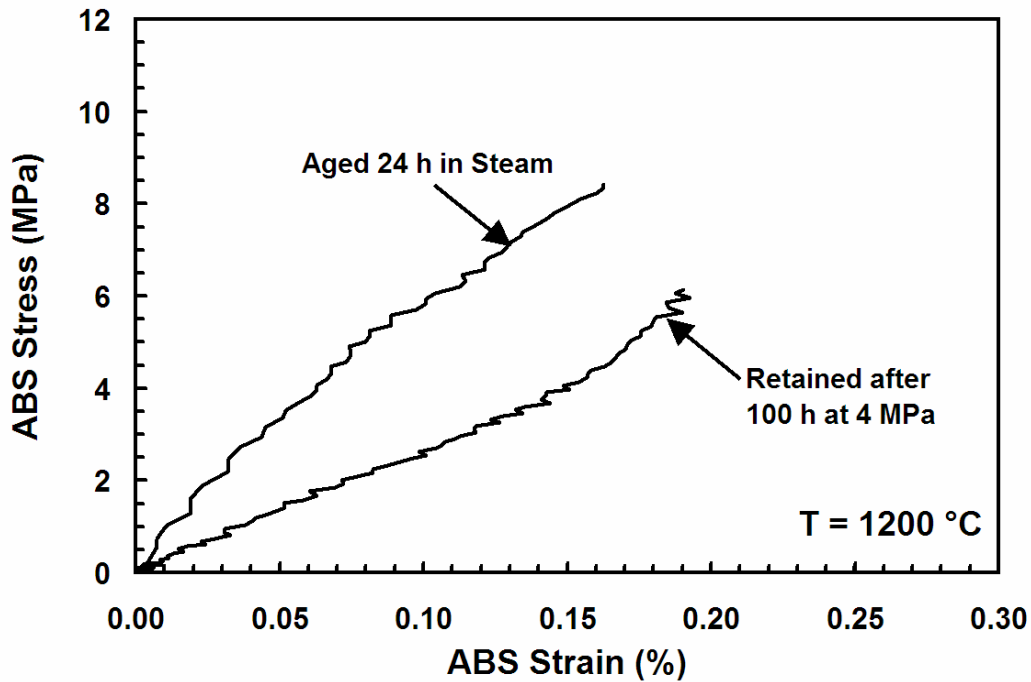
Figure 39: Effects of prior creep on the interlaminar shear properties of N720/A at 1200°C in steam.

In contrast, prior creep in steam appears to cause a decrease in interlaminar shear strength, as evidenced by the stress-strain curves in Figure 39 and in Table 8. The noticeable decrease in strength indicates that matrix weakening is taking place under sustained loading in steam.

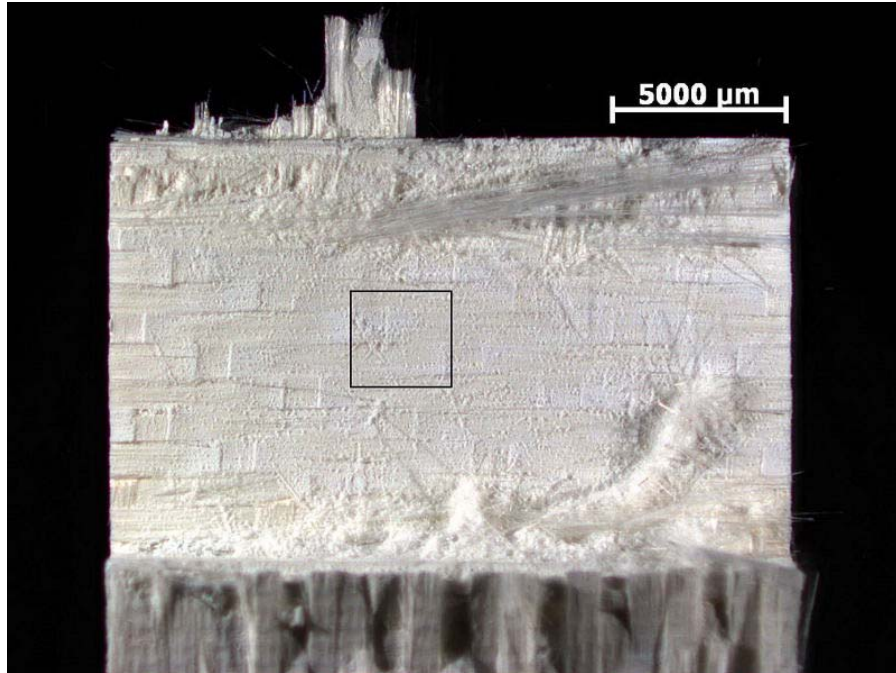
Figure 40: Fracture surface of a N720/A DNS after monotonic compression to failure in air at 1200°C.

The square section is shown in Figure 44.

All fracture surfaces were examined using the Zeiss optical microscope. Every failure occurred in the gage section as expected for a double-notched specimen. As mentioned previously, the specimen that was tested in compression to failure saw secondary failure when the test continued. The fracture surface for this specimen was shown in Figure 20. Although the original fracture surface appeared to be disturbed, the bushiness seen in Figure 20 was due to a remainder of the other piece of the composite. After this was lightly pulled away, the original fracture surface could be seen (See Figure 40). This fracture surface is very smooth where it has not been disturbed.

The next test to be completed without disturbing the fracture surface was that of the -6.5 MPa creep test in air. Failure did not occur during the creep portion of the test, so the fracture surface was produced while testing in compression for the retained properties. It can be seen in Figure 41 that the fracture surface is not uniform across the width of the specimen. This is most likely because the notches were not cut exactly to the same matrix layer on both sides of the specimen. Notice, however, that the upper left portion of the fracture surface looks very similar to that in Figure 40.

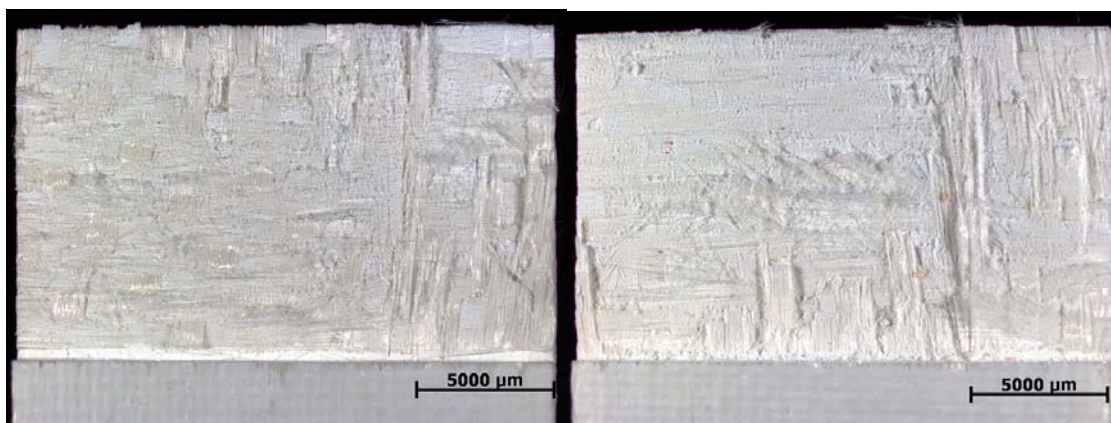
Figure 41: Fracture surfaces obtained testing for retained properties of an N720/A DNS after 100 h of creep at -6.5 MPa in air at 1200°C.

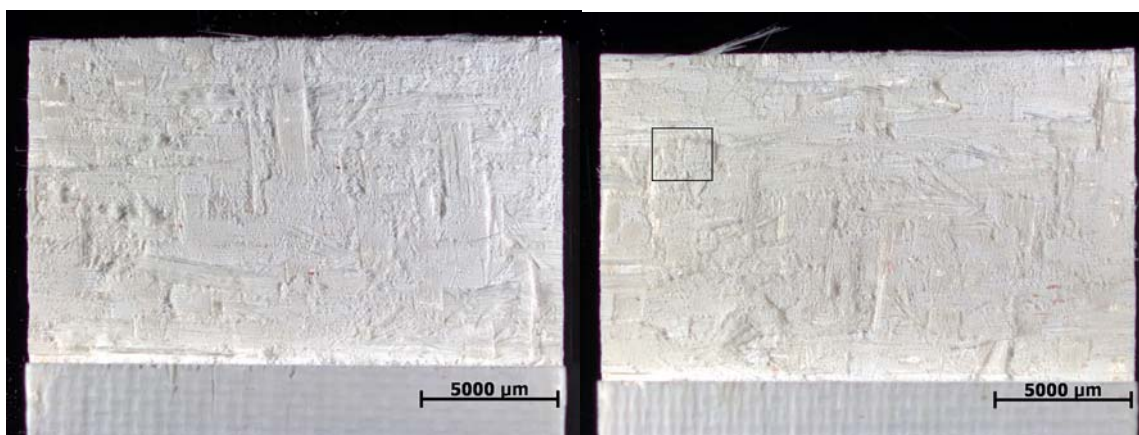
Figure 42: Fracture surfaces obtained in the compression creep test conducted on an N720/A DNS at -6.5 MPa in steam at 1200°C. The square section is shown in Figure 43.

The specimen tested at -6.5 MPa creep in steam survived only 5.7 h. In this case the fracture surfaces (See Figure 42) do not seem to be as smooth as the surfaces of the specimens tested in air. In Figure 43, there appears to be a lot of matrix and fiber pieces almost fused together where failure occurred. This is in contrast to the comminution of the matrix of the specimens tested in air as seen in Figure 44.

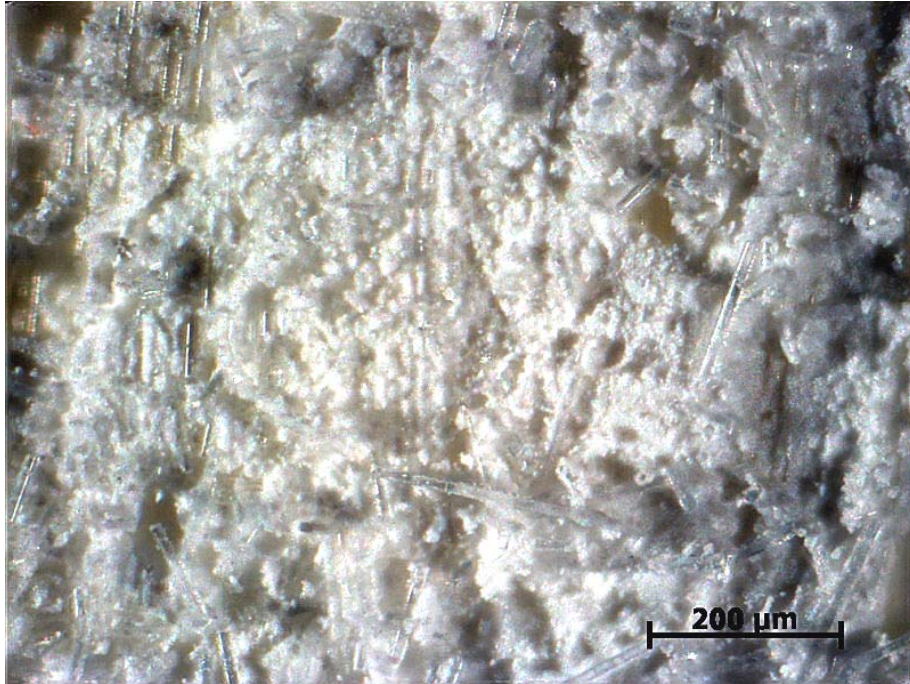
Figure 43: Close-up of the fracture surface obtained in the compression creep test at -6.5 MPa at 1200°C in steam. Alumina matrix and N720 fibers appear to be bonded together.

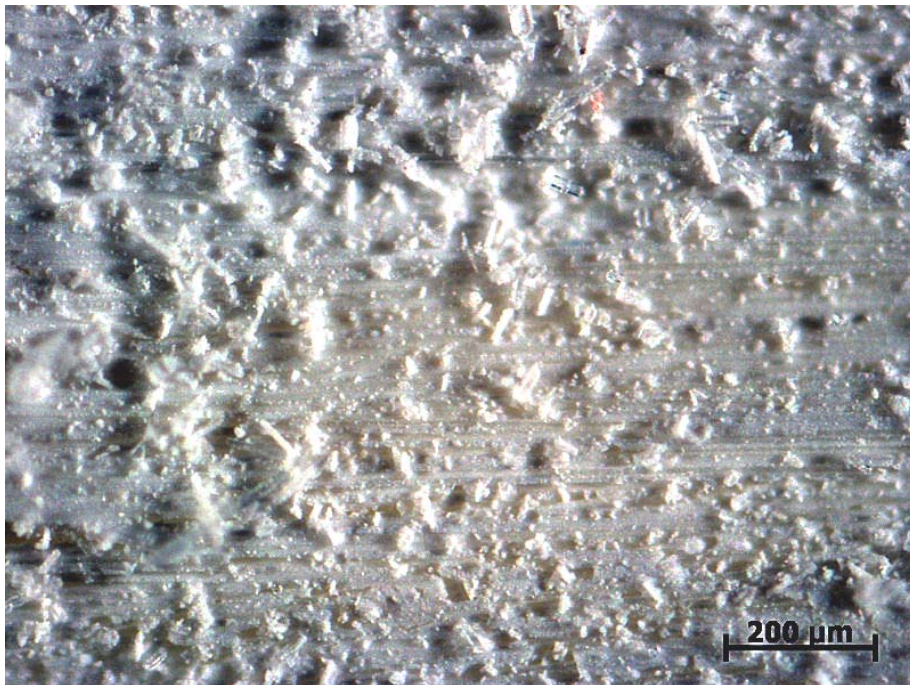
Figure 44: Comminution of the matrix of the specimen tested to failure in air.

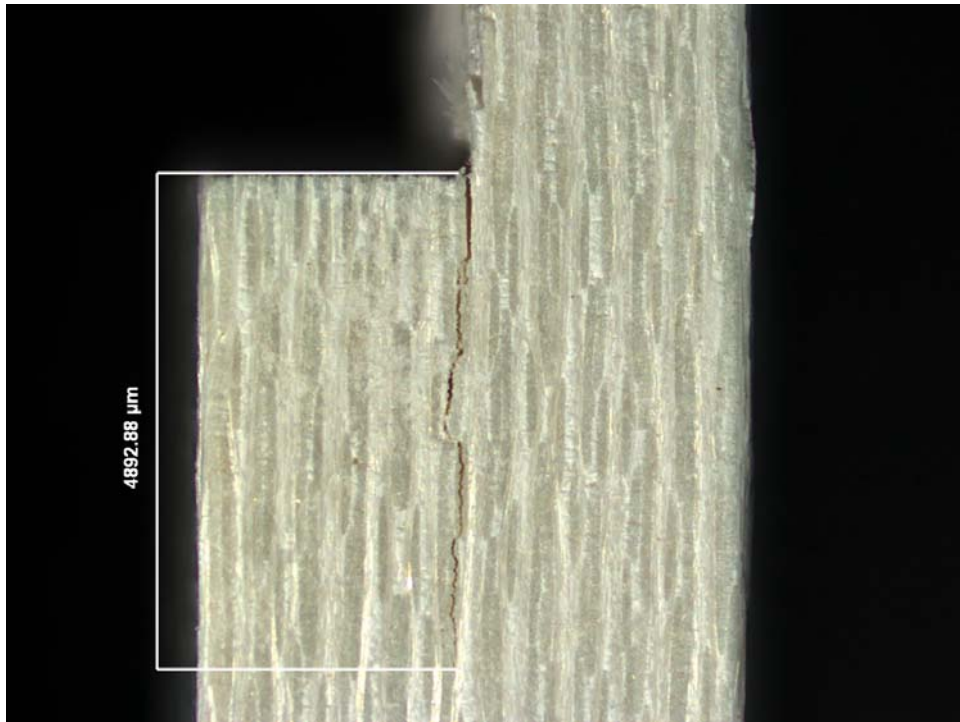
Figure 45: Fracture along the side of the composite not in the gage section of the specimen tested in -6.5 MPa creep in steam at 1200°C .

Two important observations can be made regarding the specimens tested in creep at -6.5 MPa in air and steam. The first observation reveals that the specimen tested in steam fractured along the midplane as seen in Figure 45. This crack was optically measured to be about 4.9 mm long.

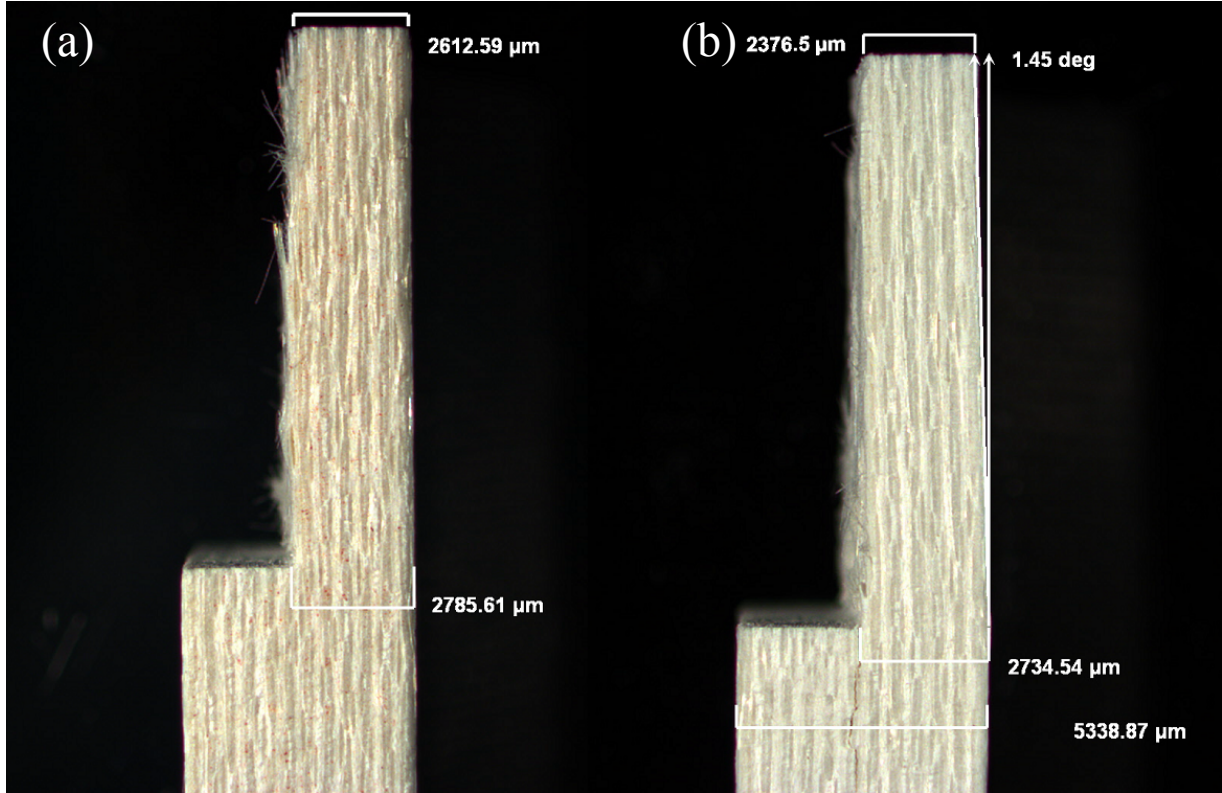
Figure 46: Side views of N720/A DNS fracture surfaces tested at 1200°C, -6.5 MPa creep. Specimen (a) was tested in air and specimen (b) was tested in steam.

The second observation reveals a change in shape of the specimen in steam when viewed from the side (See Figure 46). Two things were noticed: 1) a decrease in thickness at the end of the fractured sample and 2) a change in slope of the outside surface of the specimen. These changes were not observed for a specimen tested in air at -6.5 MPa. This change in shape and change in angle is attributed to the increased

densification of the matrix due to exposure to the steam environment at 1200°C under load.

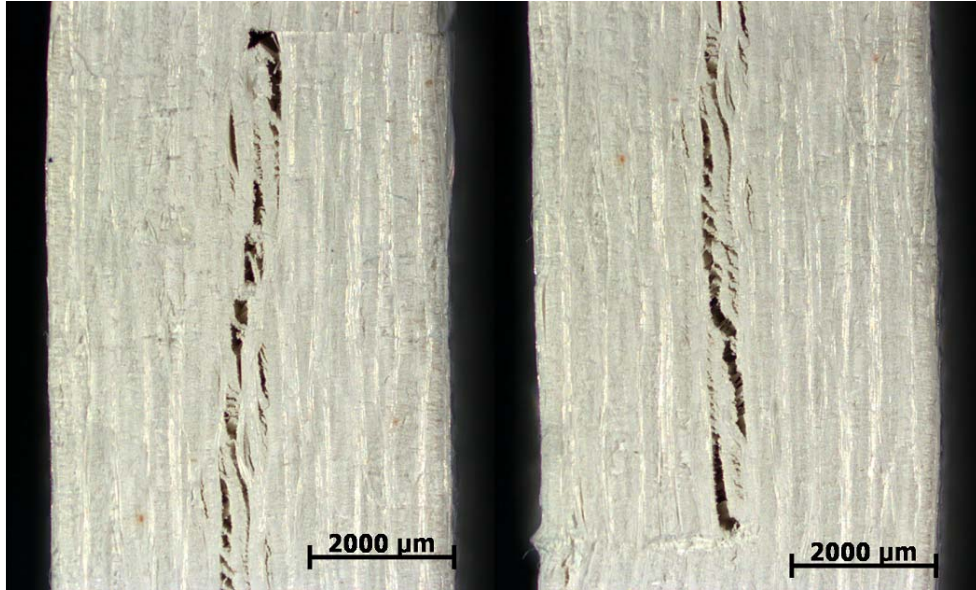
Figure 47: Side views of the N720/A specimen tested in creep at -5.0 MPa for 100 h at 1200°C.

Recall the specimen subjected to creep at -5.0 MPa in steam survived for only 8.1 h before it failed. Following failure, the specimen remained under a sustained stress of -5.0 MPa for 92 h, which caused the complete closure and “re-sintering” of the matrix. A side view of the fracture surface in Figure 47 shows that the fracture surface is not planar. Failure occurs throughout multiple plies. Considerable delamination is seen

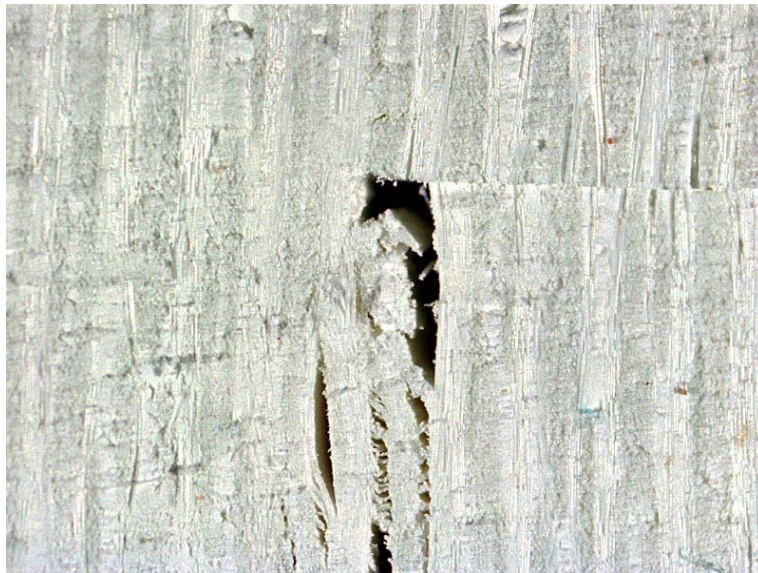
Figure 48: A close-up view of the closed notch of the N720/A specimen tested in creep at -5.0 MPa for 100 h at 1200°C.

between the two central plies. Figure 48 shows a close up image of the fracture surface where a closed and “re-sintered” notch can be seen..

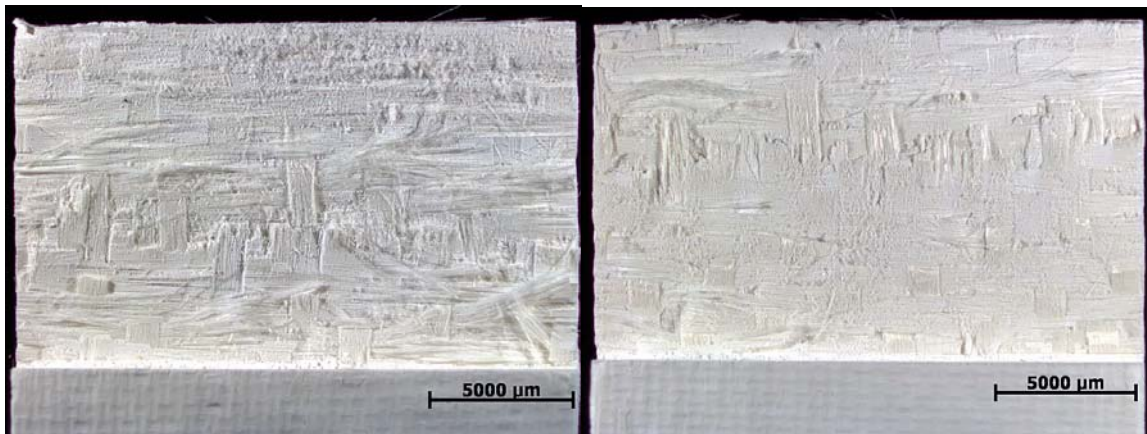
Figure 49: Fracture surfaces of specimen tested for retained properties after 100 h of creep at -4 MPa in steam at 1200°C.

The lowest creep stress level used for testing in steam was -4.0 MPa. Two specimens tested at -4.0 MPa achieved a 100 h run out. However, only the specimen that never saw a temperature change was examined under both the optical microscope and SEM. This specimen experienced failure afterward when it was tested for retained properties. Figure 49 shows that the fracture surfaces are not as smooth as those obtained in previous tests. It appears that there was considerable 0° fiber fracture across the specimen almost halfway between the notches. As with the -6.5 MPa creep specimen tested in steam, the side views revealed that the gage section was tapered from base to end (See Figure 50).

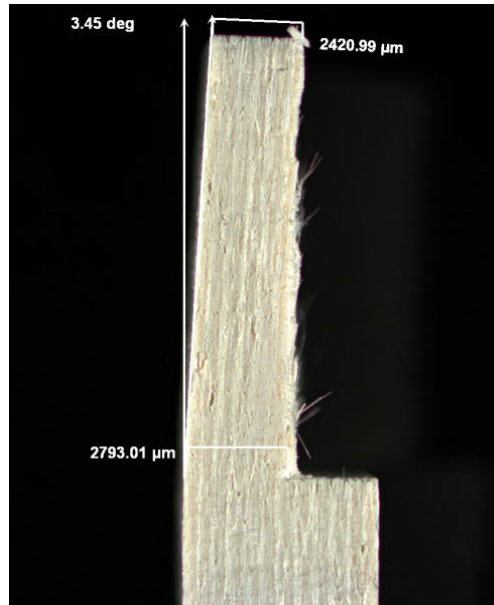
Figure 50: Side view of the specimen tested for retained properties after 100 h of creep at -4.0 MPa in steam.

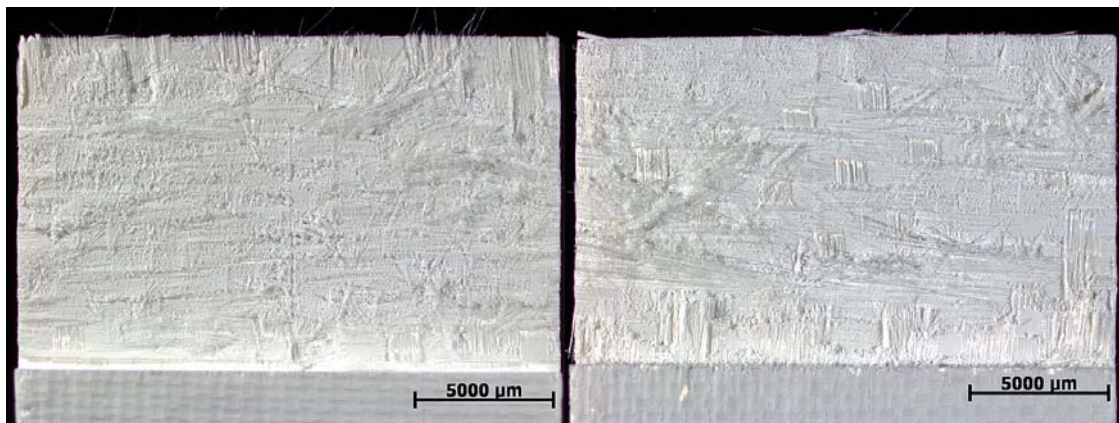
Figure 51: Fracture surfaces of the specimen aged 24 h in steam at 1200°C prior to compression to failure.

The extremely poor creep performance of the specimens in steam prompted for a test in which the specimen was aged for 24 h in steam at zero load and then subjected to compression to failure. The failure surfaces in Figure 51 show that there is some 90° fiber pullout, but very minimal 0° fiber fracture. This more closely resembles the specimen tested to failure in air than the specimens that failed during creep in steam.

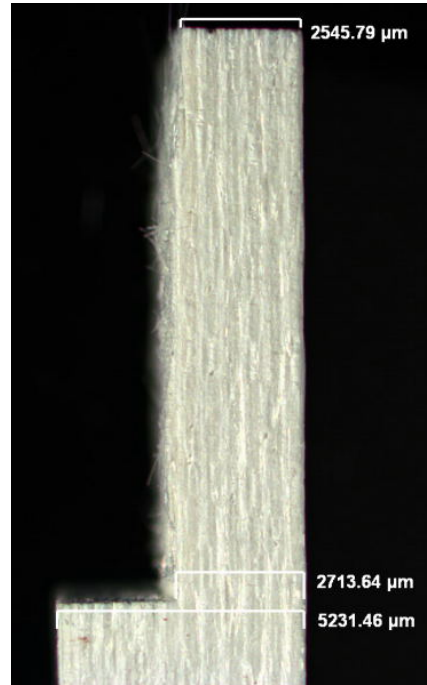
Figure 52: Side view of the specimen fracture surface aged 24 h in steam at 1200°C prior to failure.

Even though this specimen was exposed to steam 24 h prior to testing, it does not exhibit the same tapering as those tested in creep in steam (See Figure 52). This, along with the same failure stress as the monotonic compression test in air, suggests that the effects of steam alone are minimal when compared to the effects of steam and stress together.

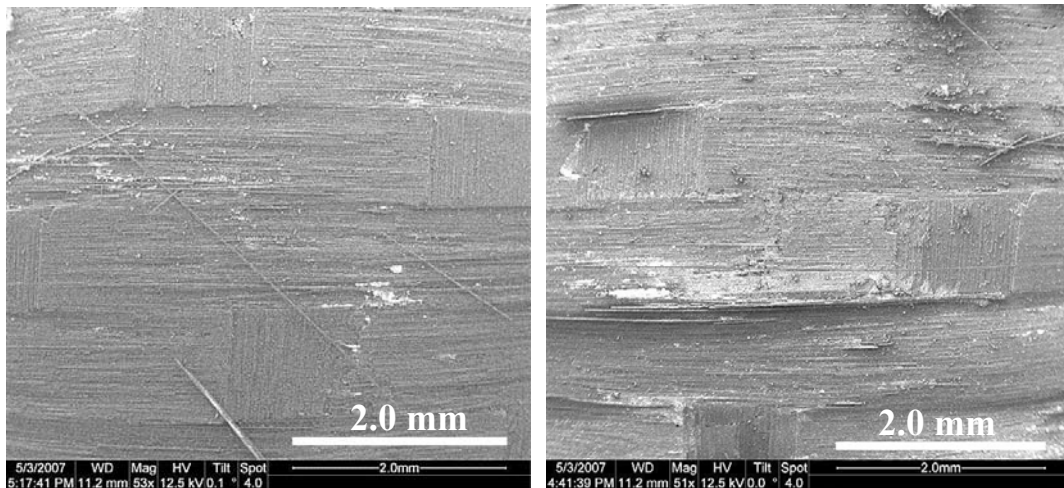
Figure 53: Fracture surfaces of the specimen tested in monotonic compression to failure in air at 1200°C.

The SEM micrographs of Figure 53 confirm how smooth the fracture surface is for the specimen that failed monotonically in air. Practically the entire surface consisted of matrix troughs. This suggests that the other surface, which was not examined under the SEM, should have consisted almost entirely of fibers. The absence of a large amount of fractured fibers indicates that the matrix was weakly bonded to the fibers. This implies that the matrix was still rather porous and did an effective job at not transferring the cracks into the fibers. Figure 54 shows how clean the surface is of the exposed fiber, also indicating a weak bond.

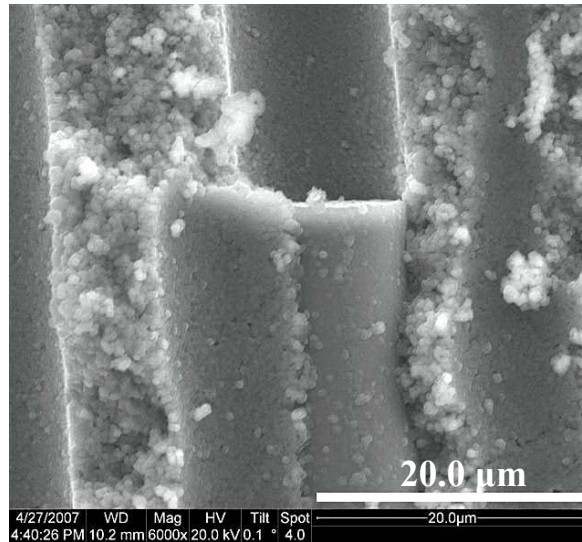
Figure 54: Exposed fiber of the specimen tested in monotonic compression to failure in air at 1200°C.

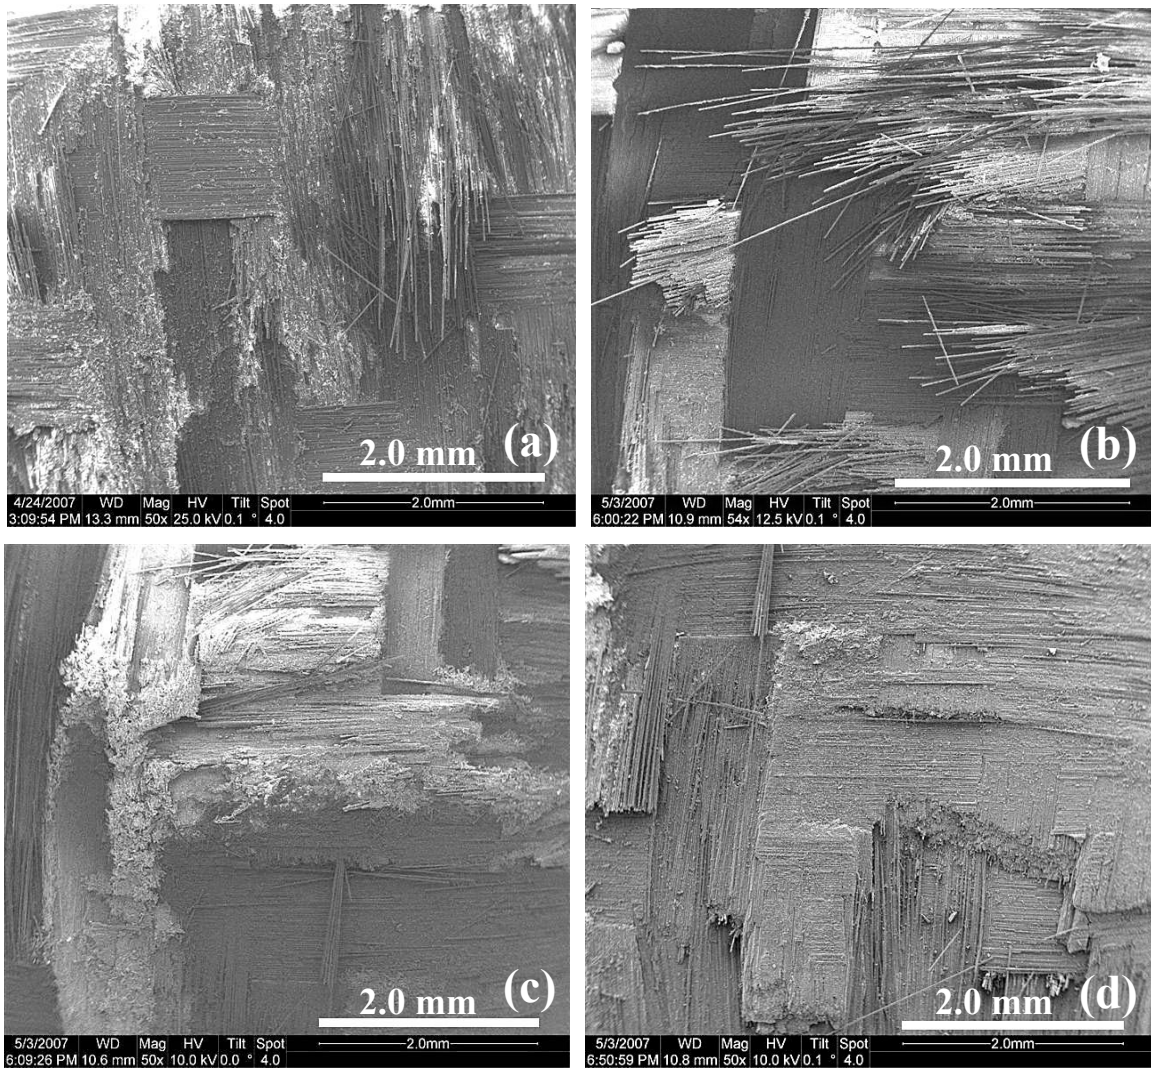
Figure 55: Various views of the fracture surface of the specimen that survived 100 h at -6.5 MPa creep in air at 1200°C.

The specimen tested in -6.5 MPa creep in air showed considerably more fiber fracture as seen in Figure 55. This, along with the increase in failure strength, suggests that the matrix became denser and more strongly bonded with the fibers. A further piece of evidence suggesting the strengthening of the fiber/matrix bond can be found in Figure 56, which was taken from the area in the middle of Figure 55 (c). These short fiber pieces were most likely created when the matrix started to crack and break. Instead of deflecting the cracks, the matrix was now sufficiently dense enough to propagate the cracks through the fibers creating many short pieces. Figure 56 (c) clearly shows just how much matrix is bonded to the fibers.

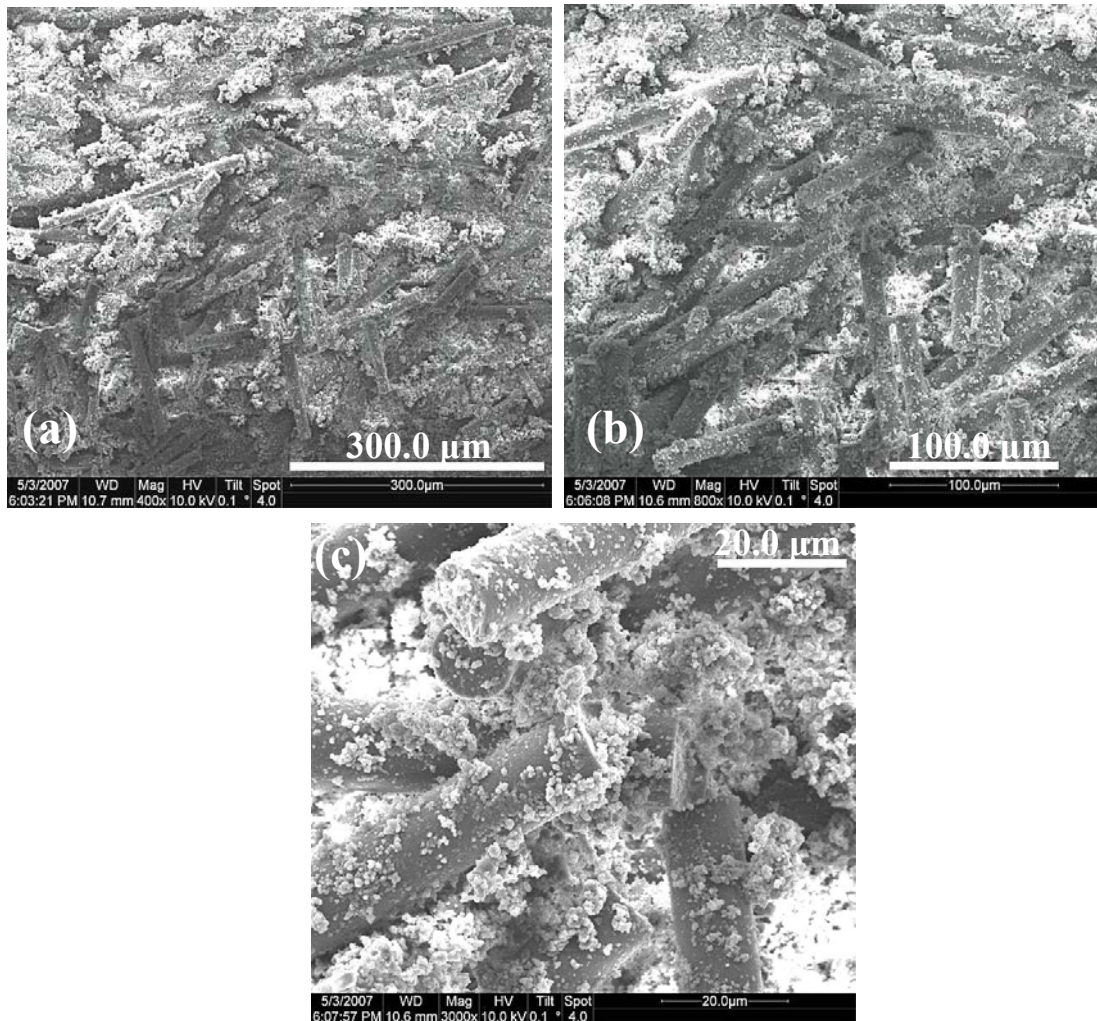
Figure 56: Progressive views of the matrix and fiber pieces that seem to have been melted together for the specimen that survived 100 h of -6.5 MPa creep in air at 1200°C.

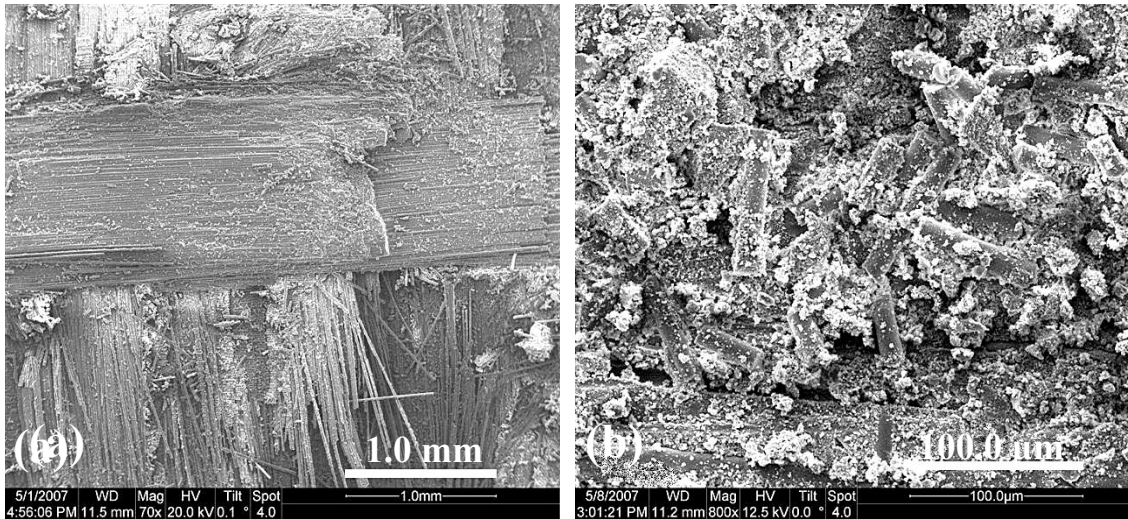
Figure 57: Specimen tested at -6.5 MPa creep in steam at 1200°C. (a) Considerable fiber fracture in the 0° direction. (b) Fiber/matrix conglomerate.

The specimen tested at -6.5 MPa creep in steam survived only 5.7 h but also exhibits both considerable fiber fracture and the fiber/matrix conglomerate found in the creep test in air (See Figure 57). The corrosion and stress corrosion of the matrix in steam has caused it to bond with the fibers very strongly, as well as weaken its load carrying capacity. Figure 58 (a) shows a fiber piece that was so strongly bonded to the matrix that it was broken in two places but never moved. Figure 58 (b) shows how the matrix was so strong that it retained its shape even after failure.

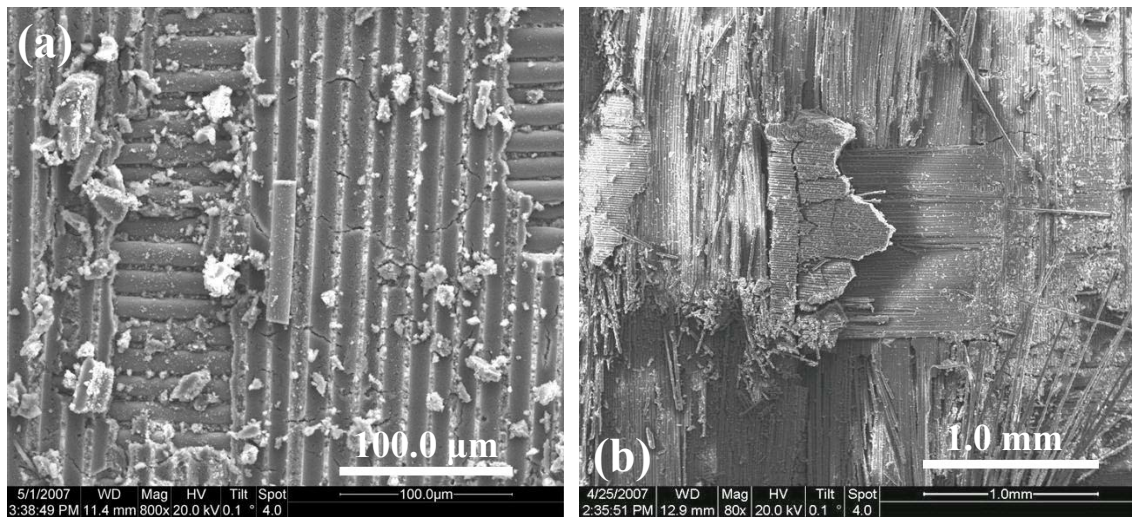
Figure 58: Specimen tested at -6.5 MPa creep in steam at 1200°C. (a) Fiber piece strongly bonded to matrix. (b) Matrix structure that did not change.

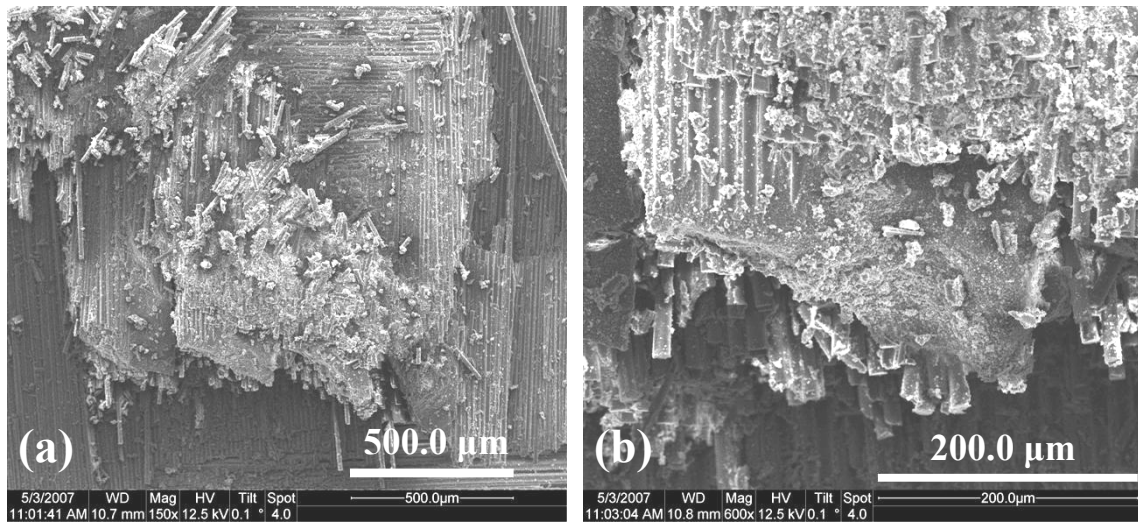
Figure 59: Two layers of fiber fracture on the specimen tested for retained properties after surviving 100 h at -4 MPa creep in steam at 1200°C. Micrograph (b) is a close-up of (a).

specimen. The fracture surfaces were also similar as observed under the SEM. There was once again considerable fiber fracture. Figure 59 shows that two layers of 0° fiber tows with a matrix layer in between were fractured. There was also a considerable amount of the fiber/matrix conglomeration as seen in Figure 60.

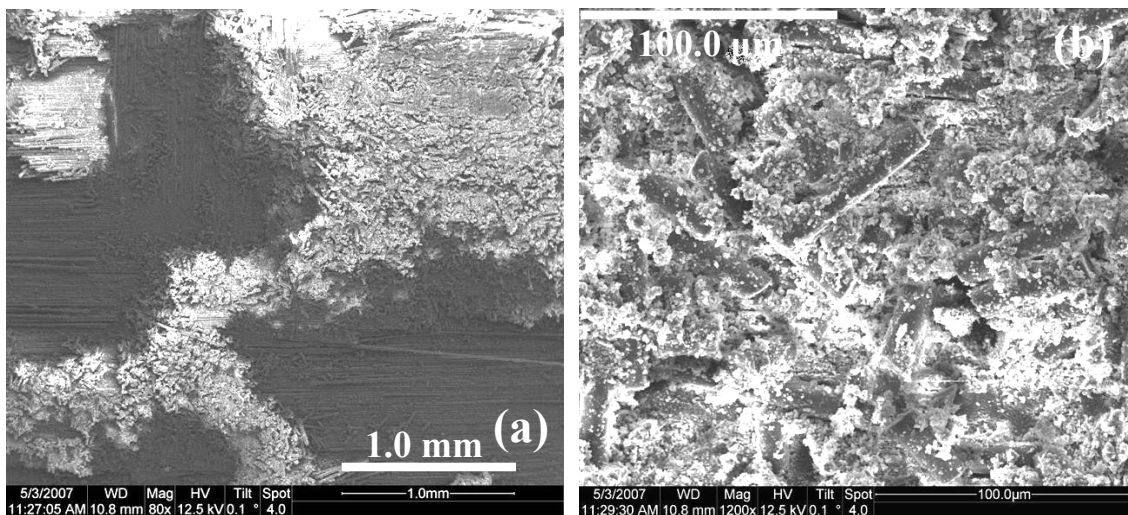
Figure 60: Fiber/matrix conglomeration on the specimen tested for retained properties after surviving 100 h at -4.0 MPa creep in steam at 1200°C. Micrograph (b) is a close-up of (a).

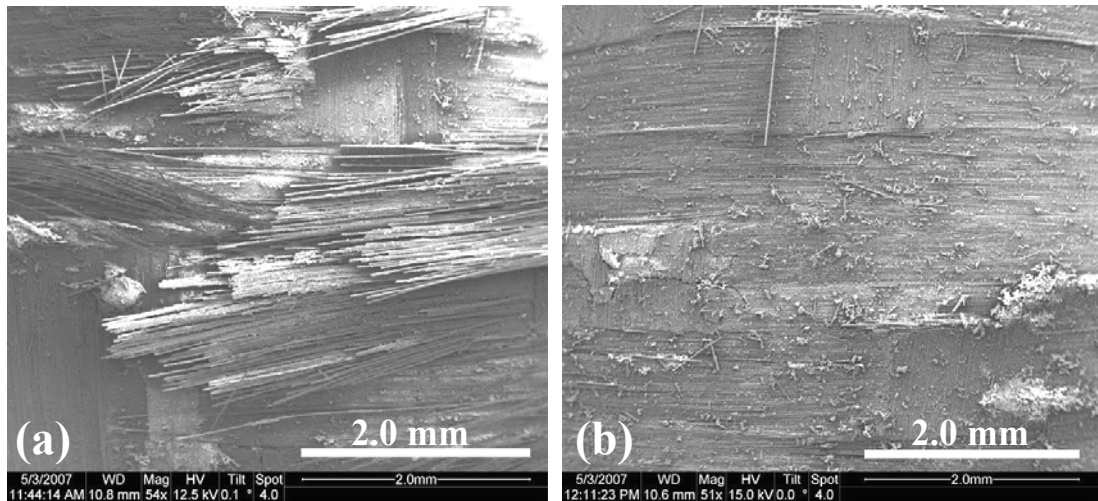
Figure 61: Fracture surface of the specimen aged in steam for 24 h at 1200°C prior to failure. (a) 90° fiber pullout observed on the fracture surface. (b) Planar portion of the fracture surface.

For the specimen aged 24 h in steam prior to loading, there was minimal 0° fiber fracture and only a small portion of 90° fiber pullout. A large portion of the fracture surface was relatively smooth compared to the specimens crept in steam (See Figure 61). There was still the presence of the fiber/matrix conglomerate as can be seen in Figure 62, yet not as much as the crept specimens.

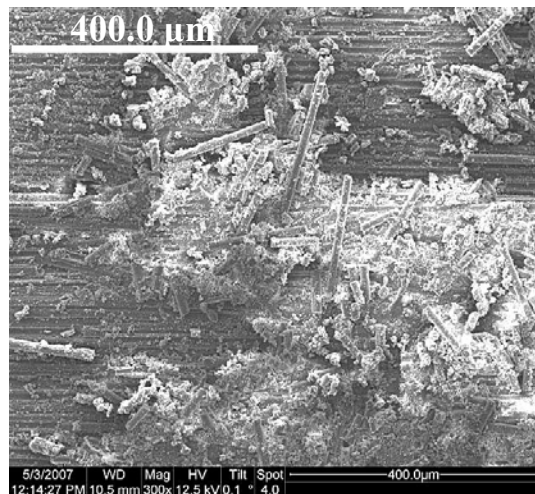
Figure 62: Fiber/matrix conglomeration seen on the surface of the specimen aged 24 h in steam at 1200°C prior to failure.

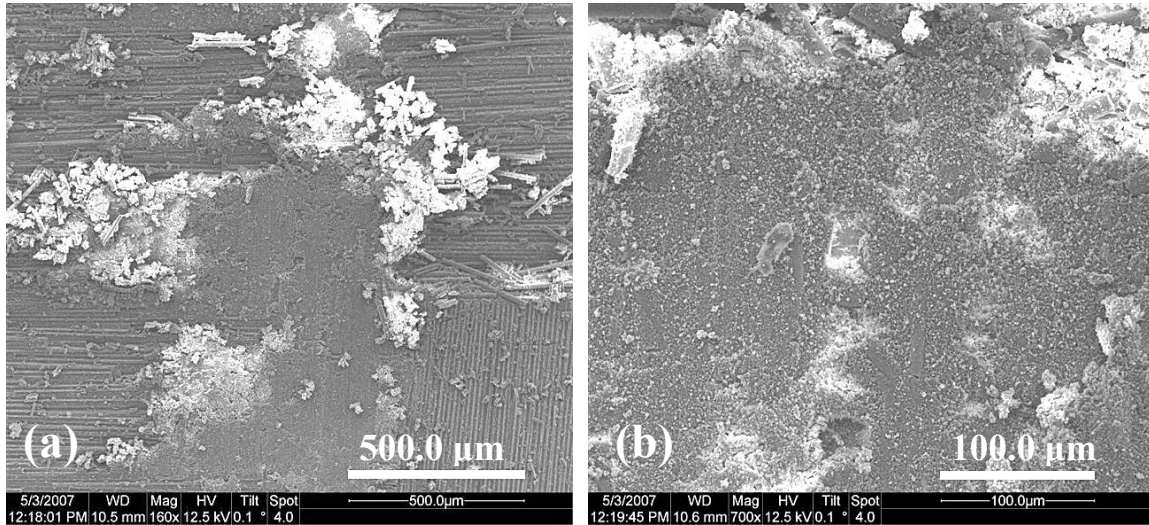
Figure 63: Matrix rich area seen on the specimen aged 24 h in steam at 1200°C prior to failure. Micrograph (b) is a close-up of the middle of (a).

One interesting finding was what appears to be a matrix rich zone on the surface of the specimen aged in steam prior to fracturing (See Figure 63). This matrix area does not show the usual troughing seen practically everywhere there is fiber pullout or the fiber/matrix conglomerate.
